# **WILLIAMSON COUNTY AERATED BIOREACTOR LANDFILL: OPERATIONS AND PERFORMANCE**

**Presented by  
Civil & Environmental Consultants  
for the  
U.S. Environmental Protection Agency  
Workshop On Bioreactor Landfills  
February 27-28, 2003**

# WILLIAMSON COUNTY LANDFILL

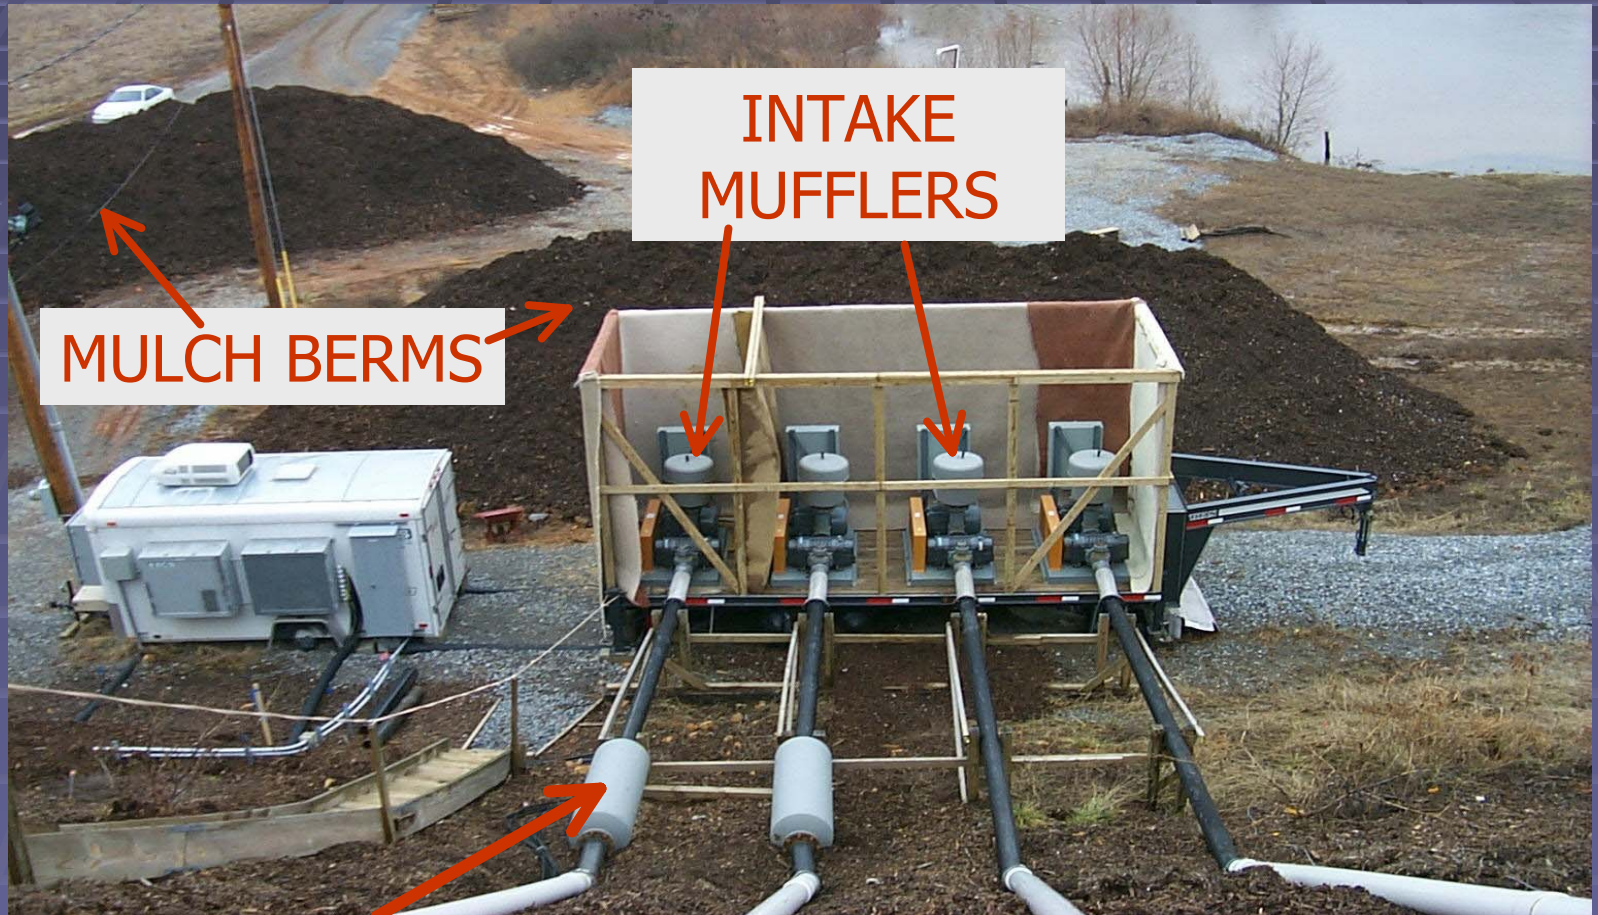
- **PROBLEM:** Noise from blowers (neighbor complaints)

# POSITIVE DISPLACEMENT BLOWERS WITH NOISE ABATEMENT MEASURES

- **SOLUTION:** Vibration dampeners on outlet air header pipes; mufflers on blower intakes; carpeted structure around blowers

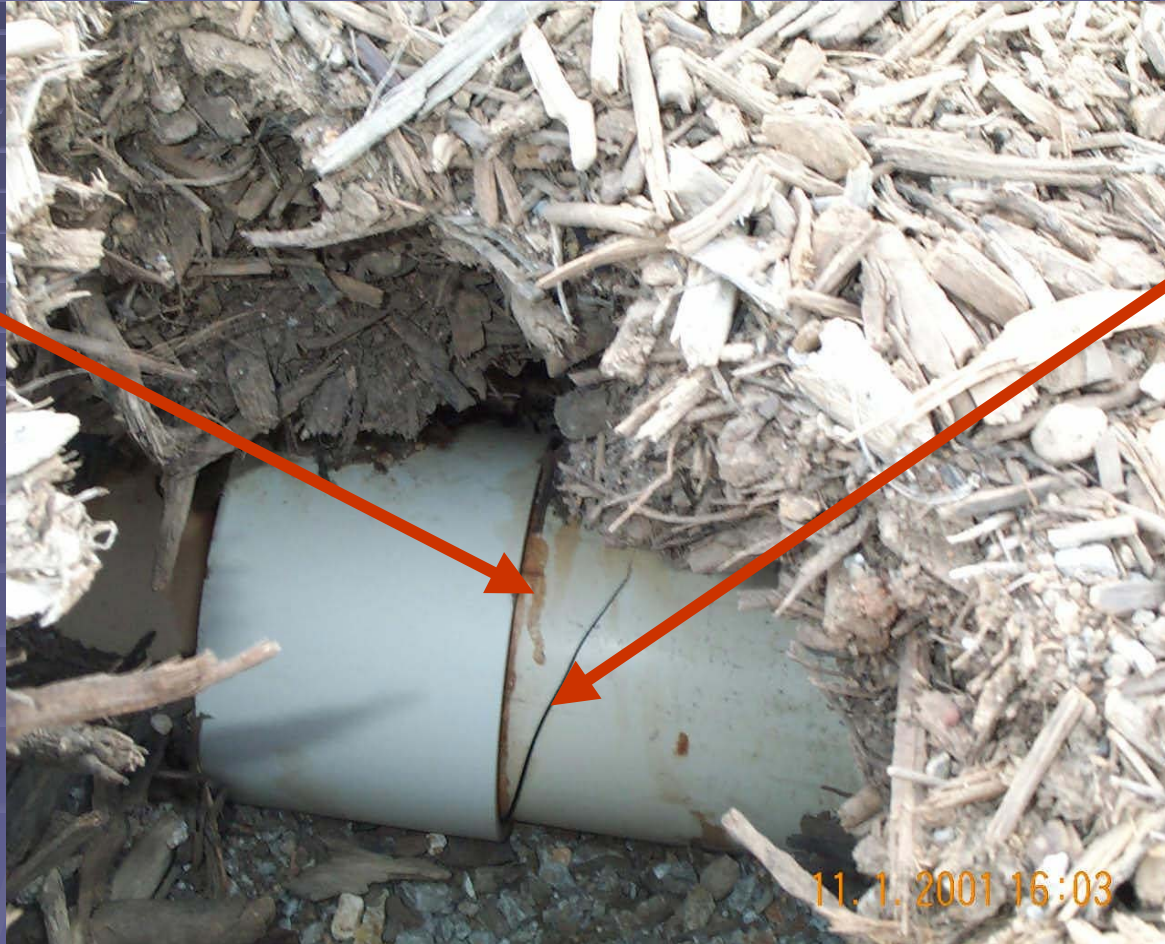
➤ **PROBLEM:** Maintaining air header pressure due to pipe leaks at cracks and due to inadequate sealing at joints

**Separation  
At PVC  
Glued  
Joints**

**Crack  
Formation  
In PVC  
Pipe**

➤ Replaced cracked pipe and all leaking joints

➤ Use HDPE pipe with butt-fused joints

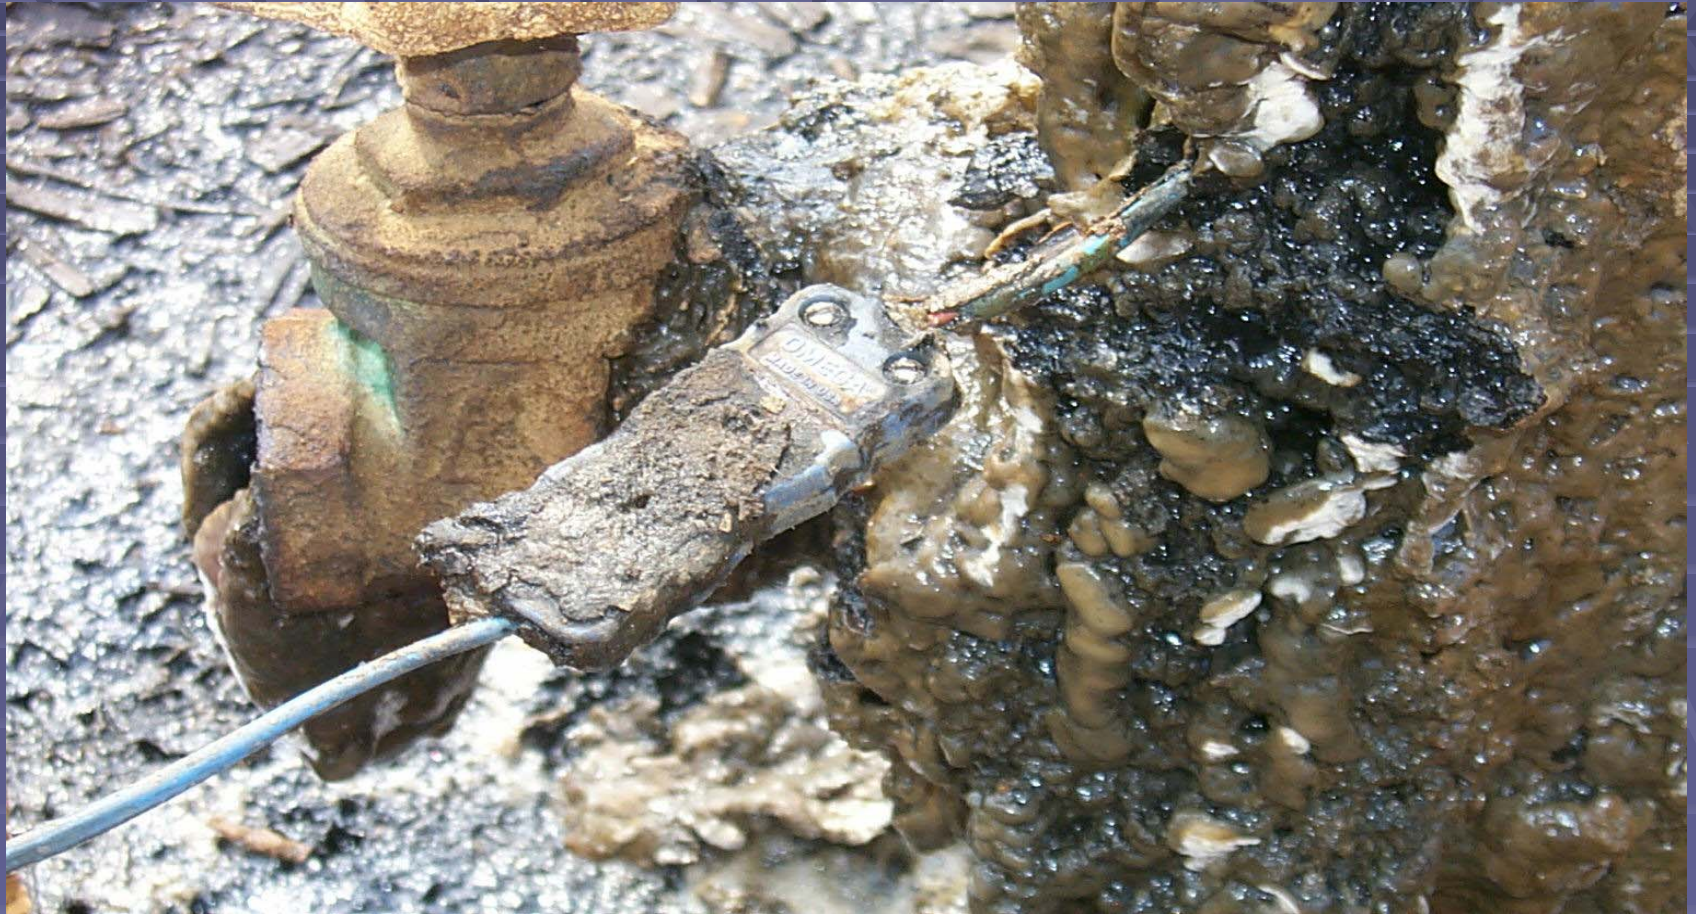
- Sealing Connections
- Shielded wire was not used
- Accidental severing of Lines
- Wires wrapped around piping

# PRECIPITATE AND CORROSION AT THERMOCOUPLE CONNECTOR

- Replacement of wire; use of shielded wire
- Shrink-Wrap Connections or replace with outdoor connectors (watertight)
- Remove wires from around piping

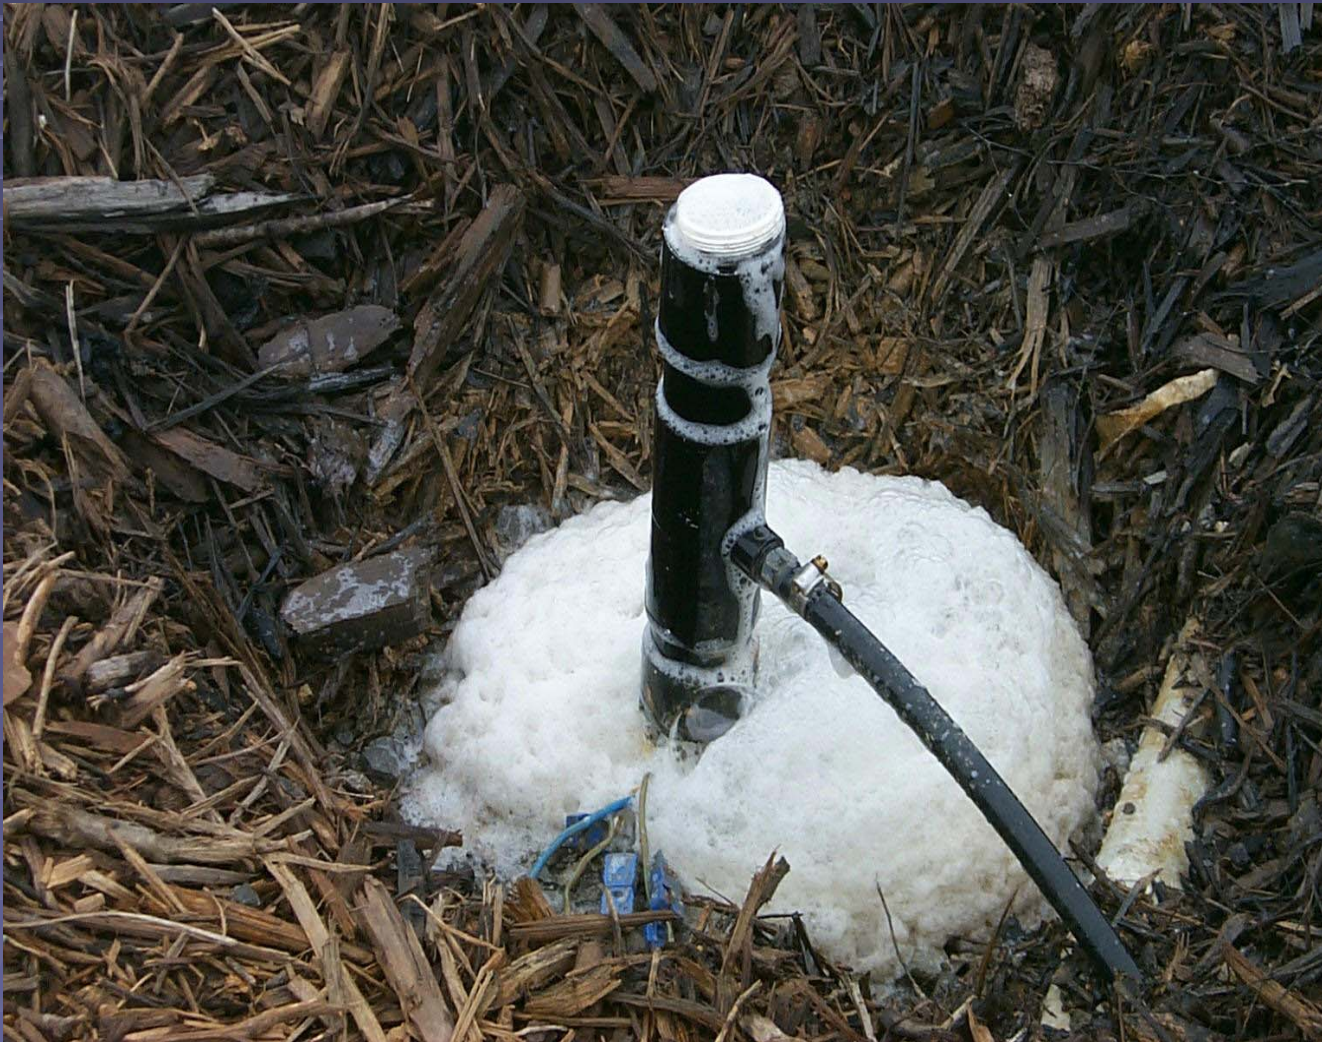
- **PROBLEM: Backflow/Surge of leachate from injection wells**
  - Leachate ejection onto base of wells
  - Backflow into air pipes when blowers are off)
  - Probable cause:
    - excessive internal gas production and associated pressures along with increasing heat

# LEACHATE BACKFLOW/SURGE

- **Throttle valves at well heads;**
- **Construct mulch berms to contain surcharge and prevent it from leaving site as stormwater;**
- **Periodic leachate dosing;**
- **Check valves on air lines to prevent leachate backflow**

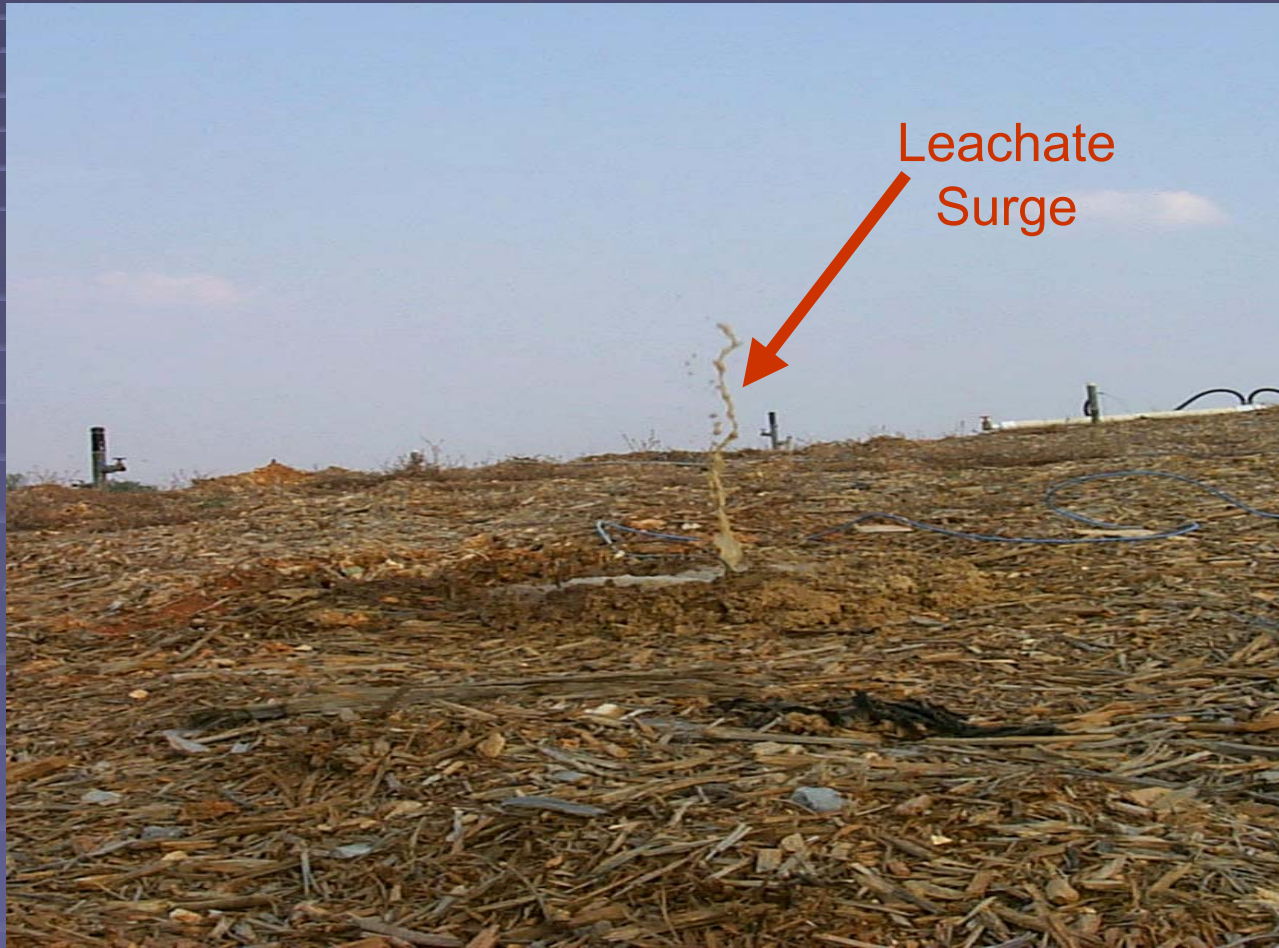
# LEACHATE BACKFLOW/SURGE

Leachate  
Surge

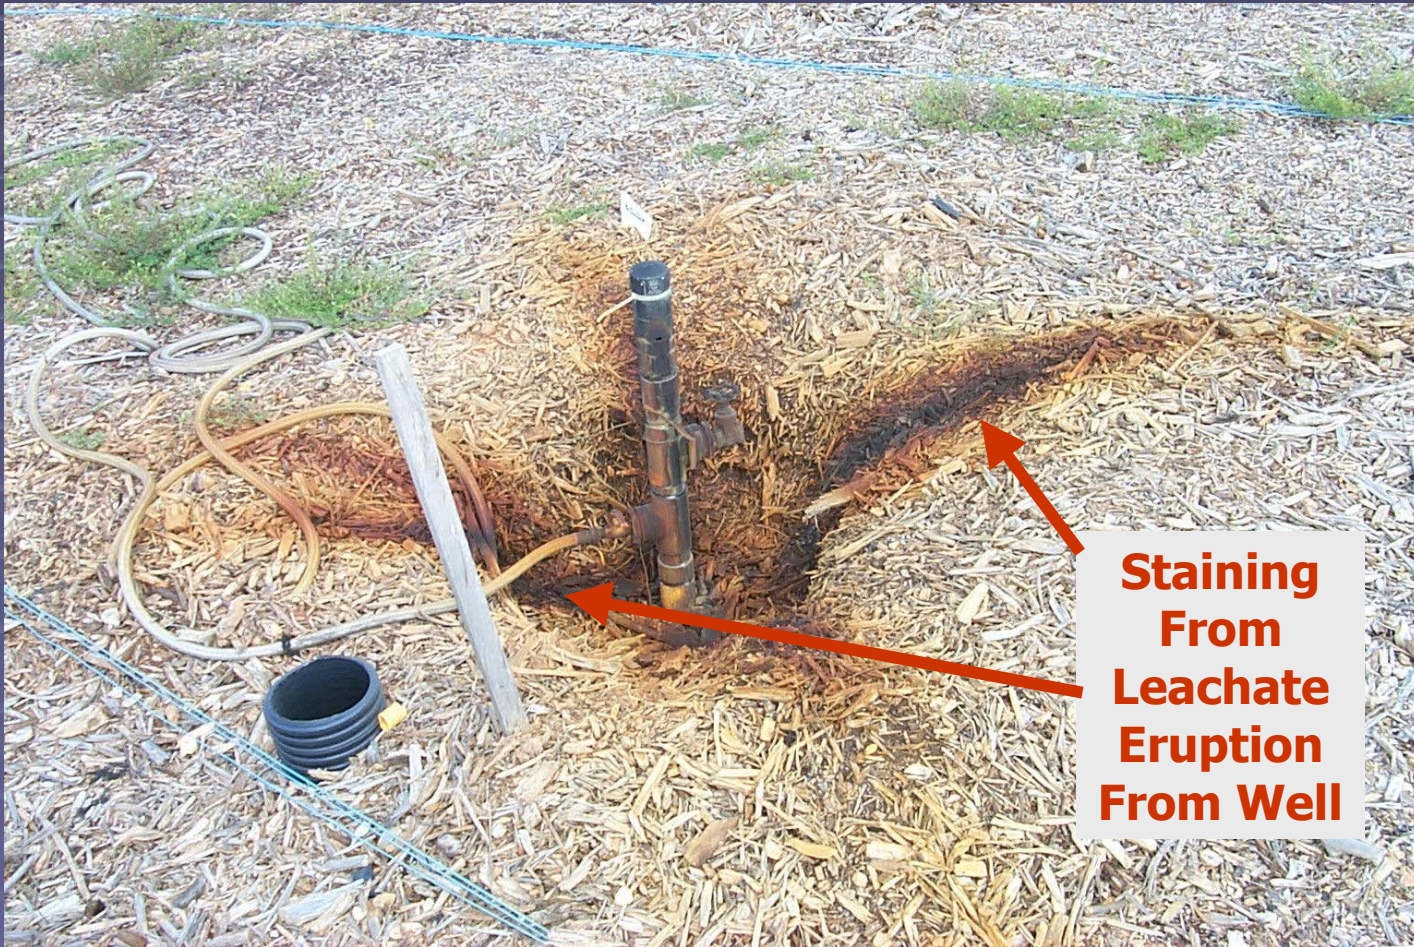
# LEACHATE SURGE

**Staining  
From  
Leachate  
Eruption  
From Well**

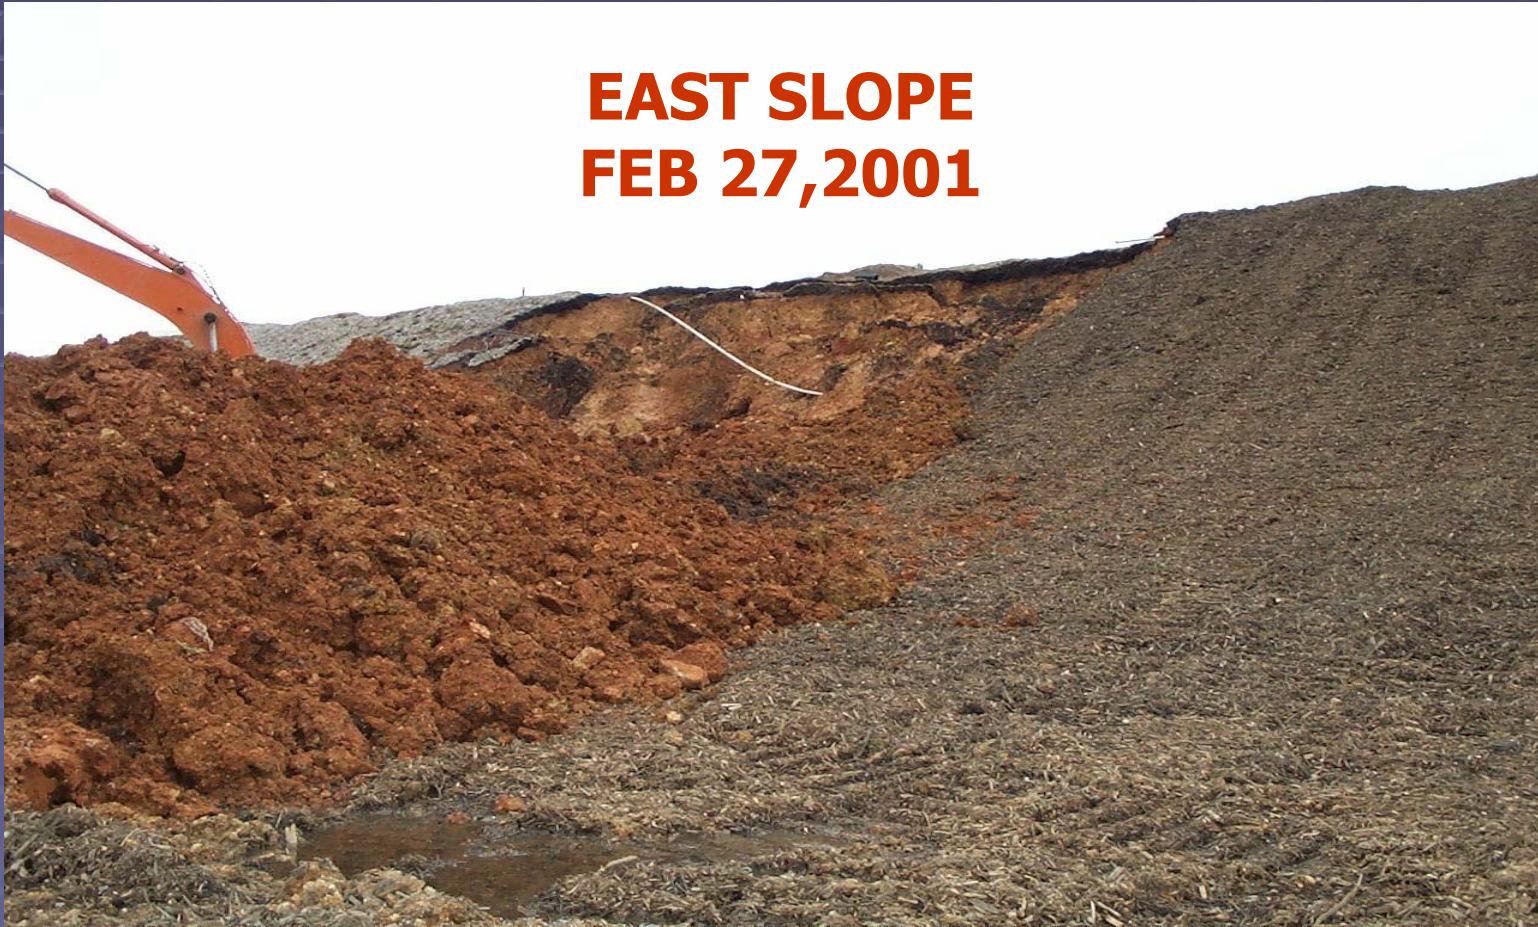
**EAST SLOPE  
FEB 27, 2001**

# GEOTECHNICAL STABILITY

- **Continued monitoring of slope movement via sideslope risers**
- **All injection wells (air and leachate) located near top edge of slope have been shut off**
- **Rock buttresses built along south sideslope**

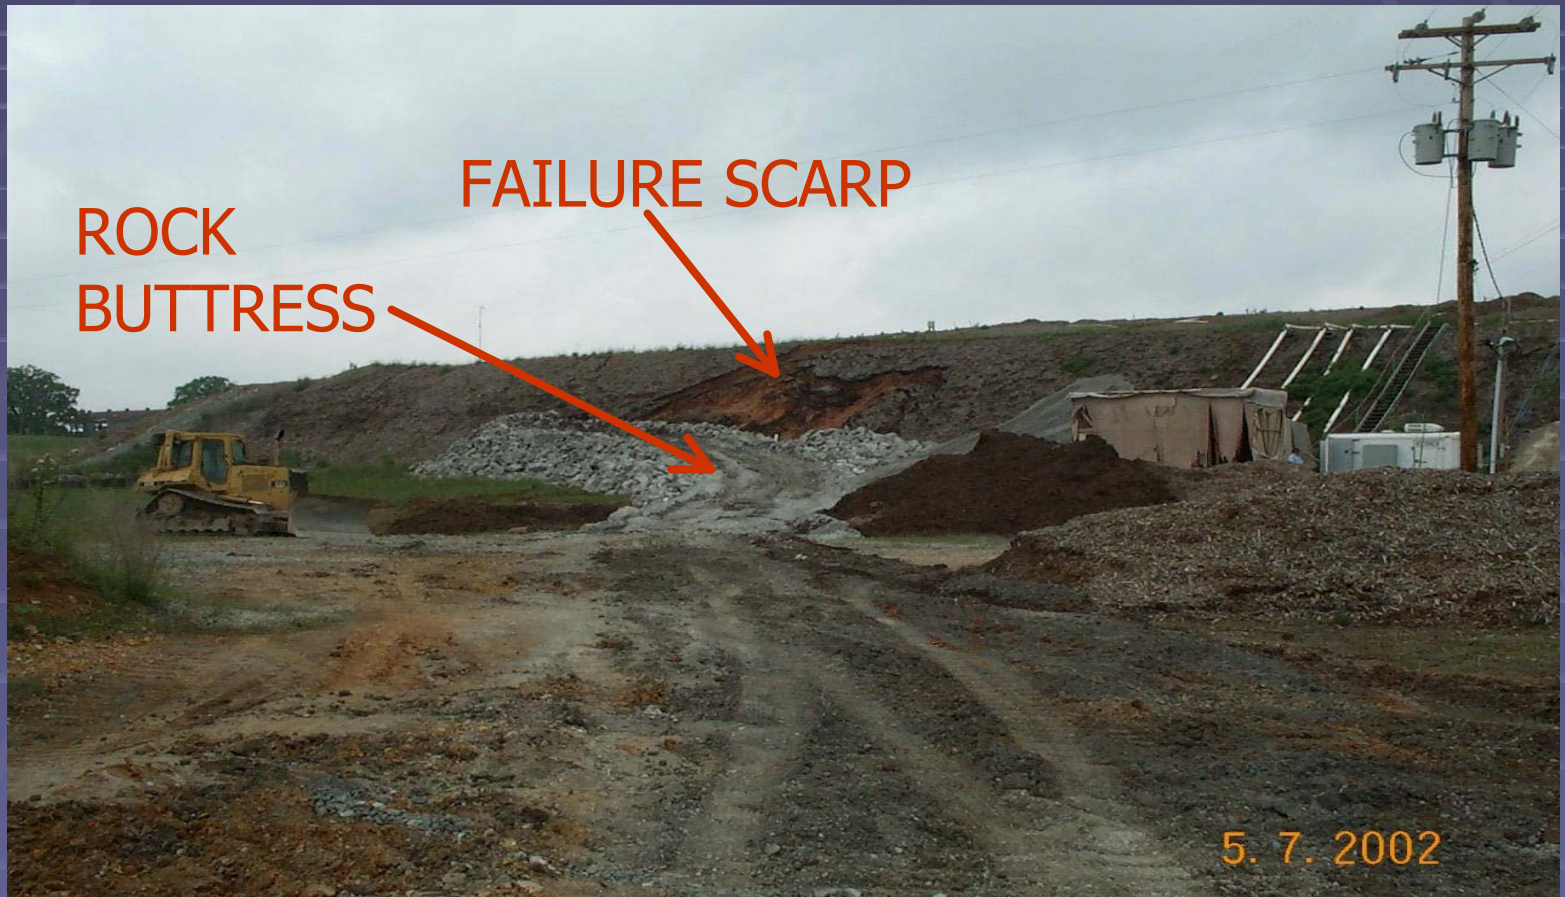
**SOUTH SLOPE – MAY 7, 2002**

# GEOTECHNICAL STABILITY

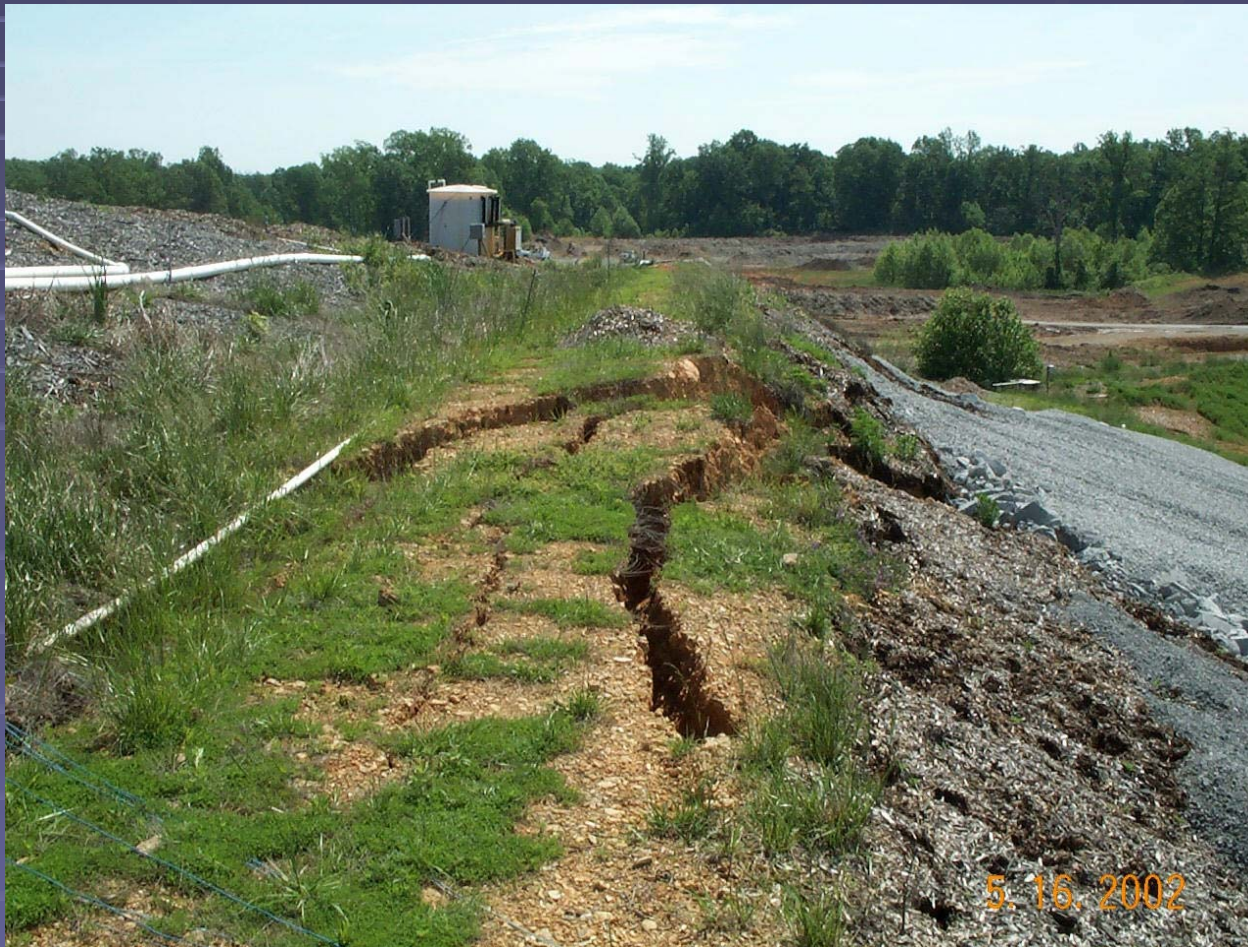
**South Slope- May 2002**

# GEOTECHNICAL STABILITY
