# **WILLIAMSON COUNTY AERATED BIOREACTOR LANDFILL: OPERATIONS AND PERFORMANCE**

**Presented by  
Civil & Environmental Consultants  
for the  
U.S. Environmental Protection Agency  
Workshop On Bioreactor Landfills  
February 27-28, 2003**

# WILLIAMSON COUNTY LANDFILL

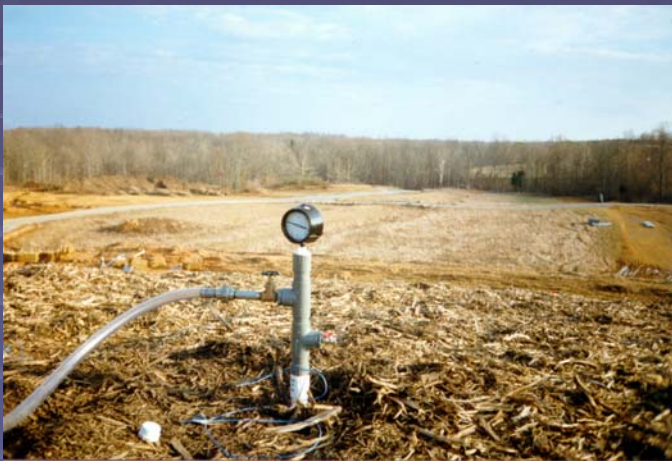
➤ Excessive air backpressures at air injection wells

➤ Related to the variability in waste/soil density and porosity (limited free air-space), volume of intermediate soil cover used, moisture content

➤ Related to the method of construction for the injection wells

- SOLUTION/RESPONSE:
- Construct waste cells in new bioreactor systems using methods to increase free air-space (waste processing, minimal compaction, shallow layering)
- Compare measured backpressures in the field using various delivery methods
- Internal examination of wells with down-hole camera

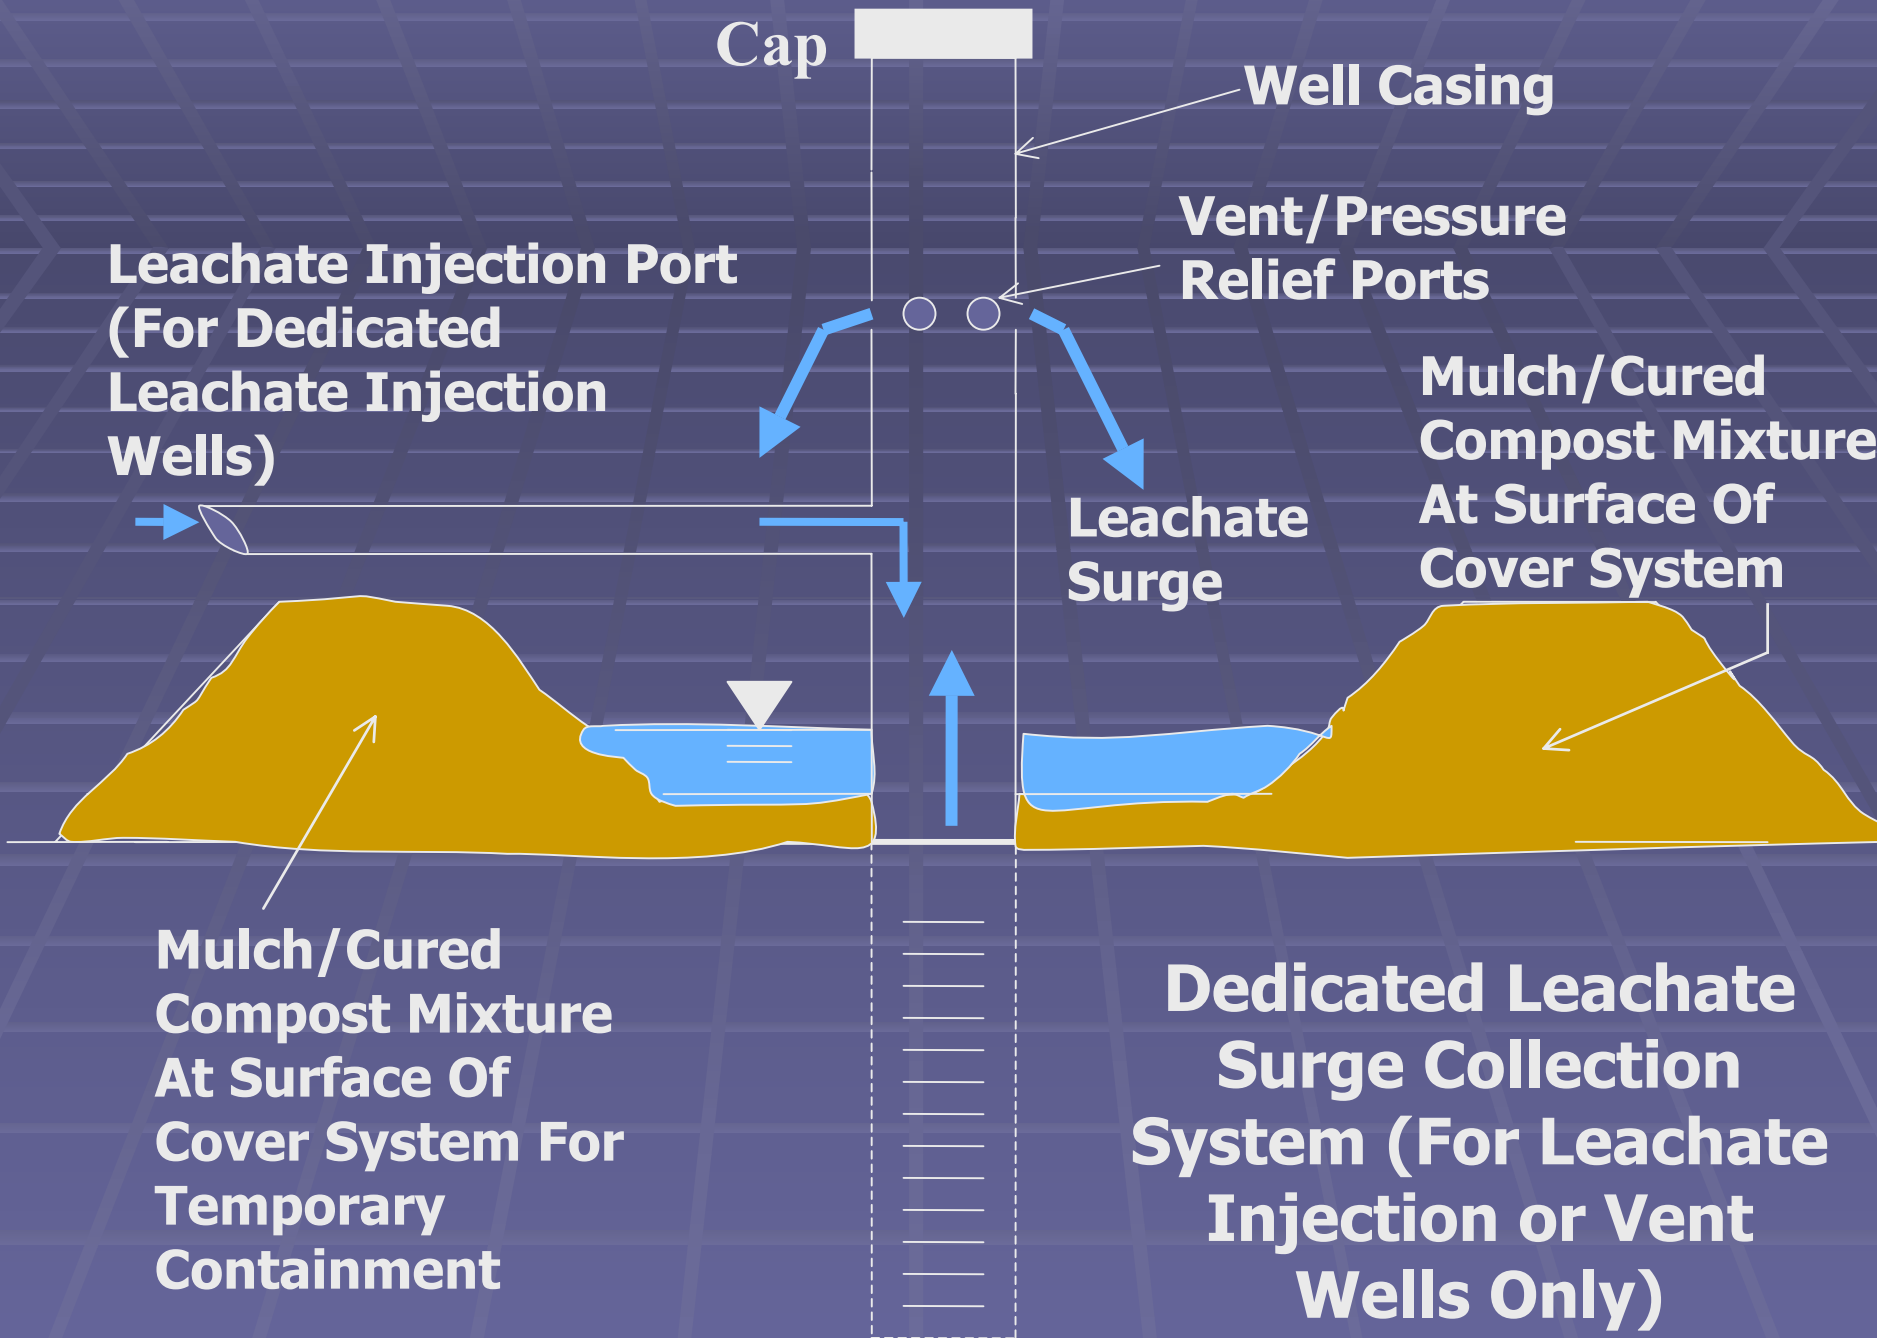
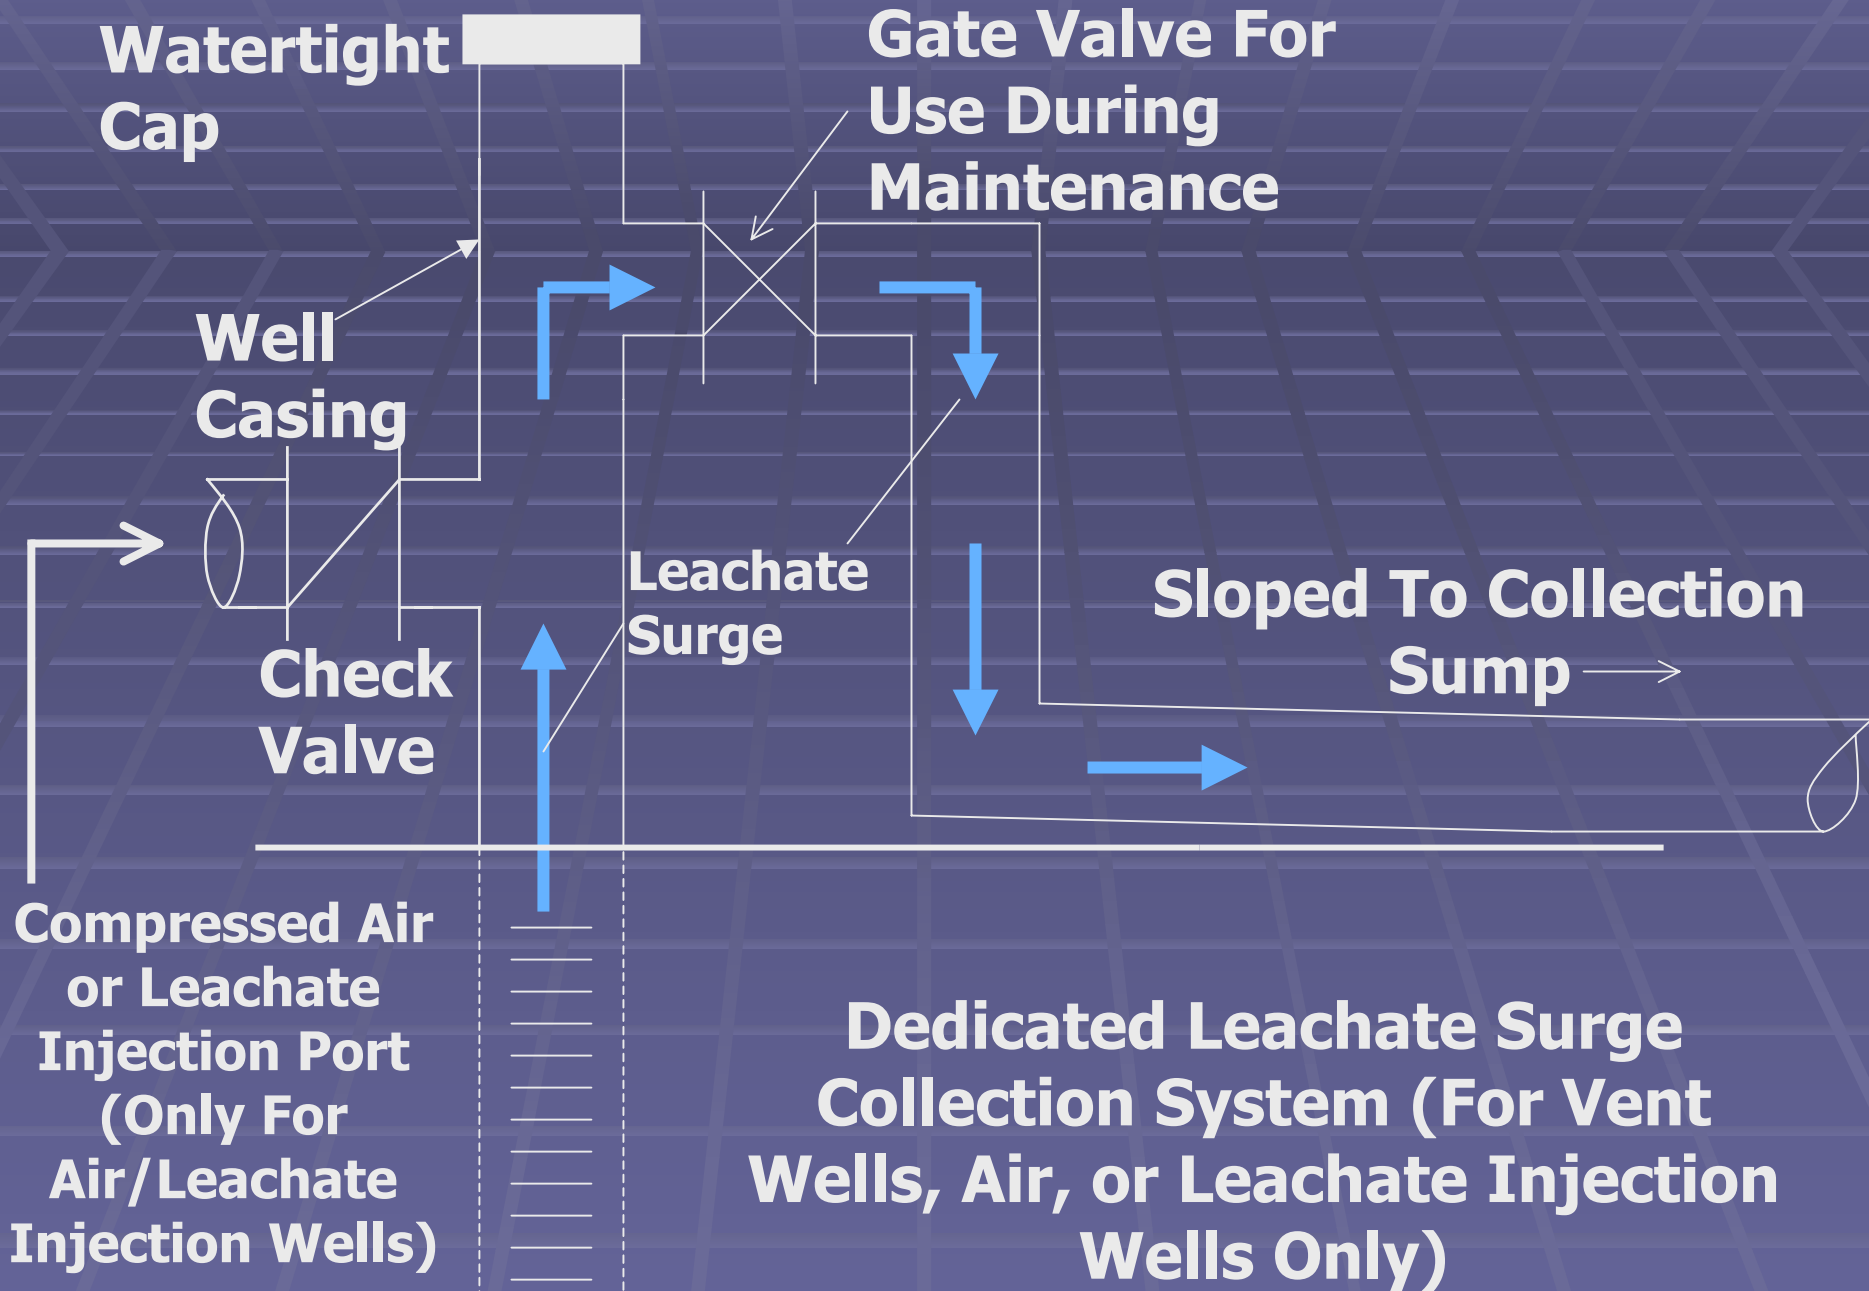
- **PROBLEM: Backflow/Surge of leachate from injection wells**
  - Leachate ejection onto base of wells
  - Backflow into air pipes when blowers are off)
  - Probable cause:
    - excessive internal gas production and associated pressures along with increasing heat

- **Throttle valves at well heads;**
- **Construct mulch berms to contain surcharge and prevent it from leaving site as stormwater;**
- **Periodic leachate dosing;**
- **Check valves on air lines to prevent leachate backflow**
